Saturn Helium Bottles

Contract NAS 8-11555

Report on Problems Associated
with Heat Treatment

ER 13796

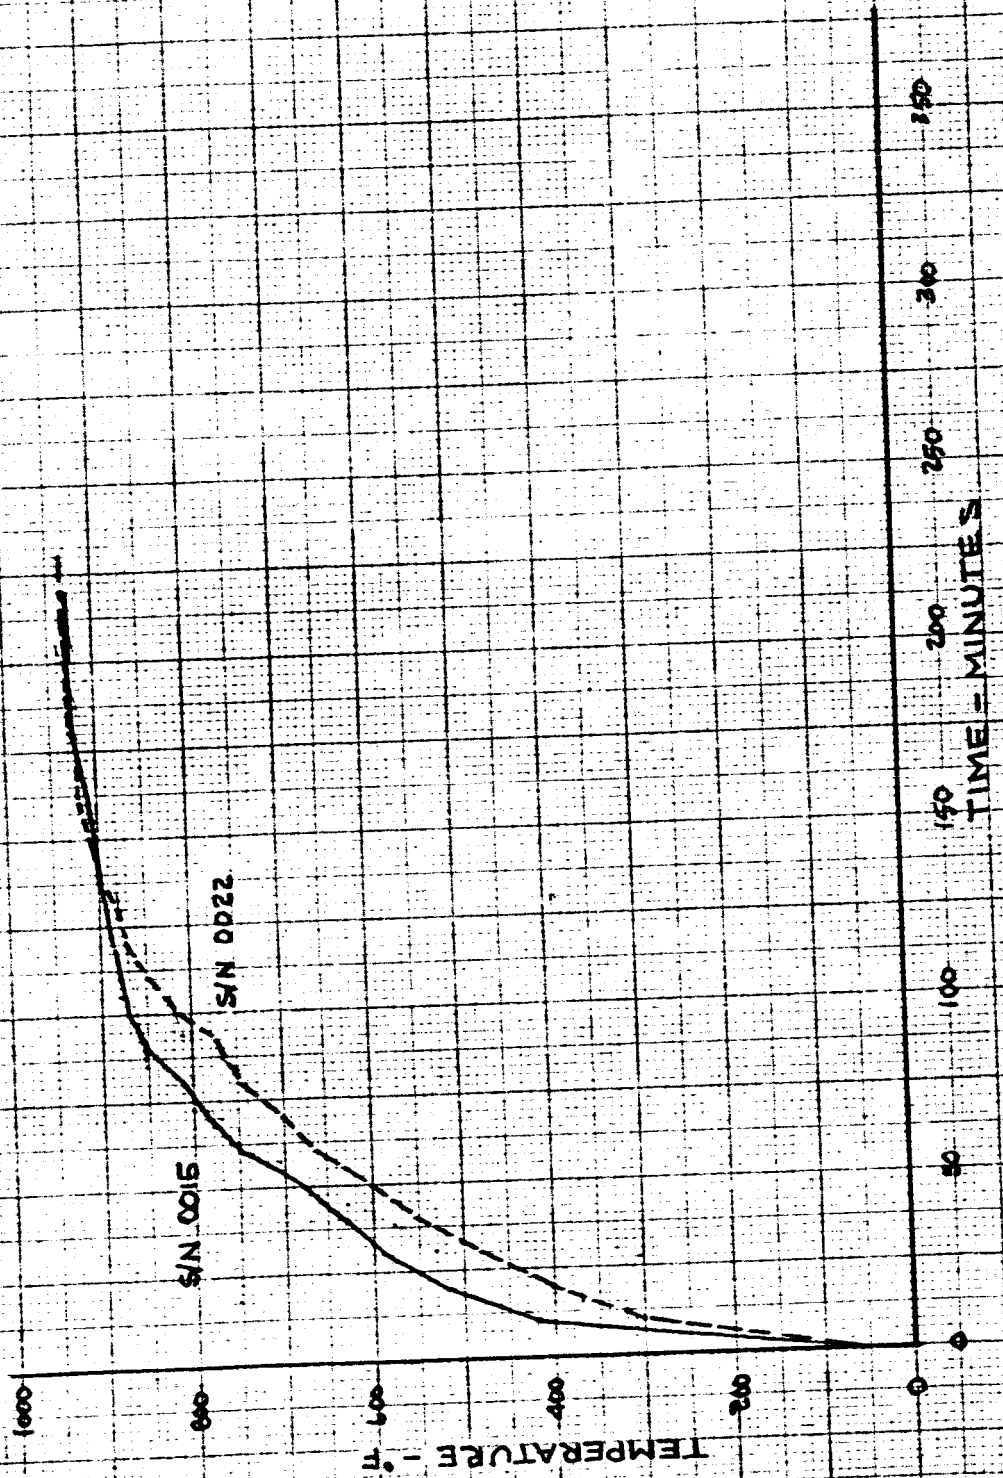
FIG. 5: TEMPERATURE-TIME HISTORIES - UNDERHEATED SERIES

Figure 5 presents the temperature-time histories for S/N 0015, the best of the good units, and S/N 0022, the worst of the bad units. Figure 5 shows that up to about 150 minutes there was a significant difference in the rate of temperature rise. If Fig. 1 is compared with Fig. 5, it will be seen that the rate of rise on the test unit shown in Fig. 1 falls between the two curves shown in Fig. 5. It can be concluded that at any instant of time the lag between the outside bottle surface temperature and the inside surface temperature would be less for S/N 0015 than for S/N 0022. The effect of the cold spot in the furnace would probably increase this lag. It is further concluded, that during the hold period, even though both units had essentially the same temperature on the outside surface, the inside surface of S/N 0022 was lagging by as much as 50°F. The underheating of the six units would not have occurred if either the initial rate of heating had been higher or the total time for the cycle had been extended to 300-400 minutes.

The six suspect units are presently in the process of being reheat treated and additional controls have been imposed on the Vendor. These additions to the process will be discussed later in this report.

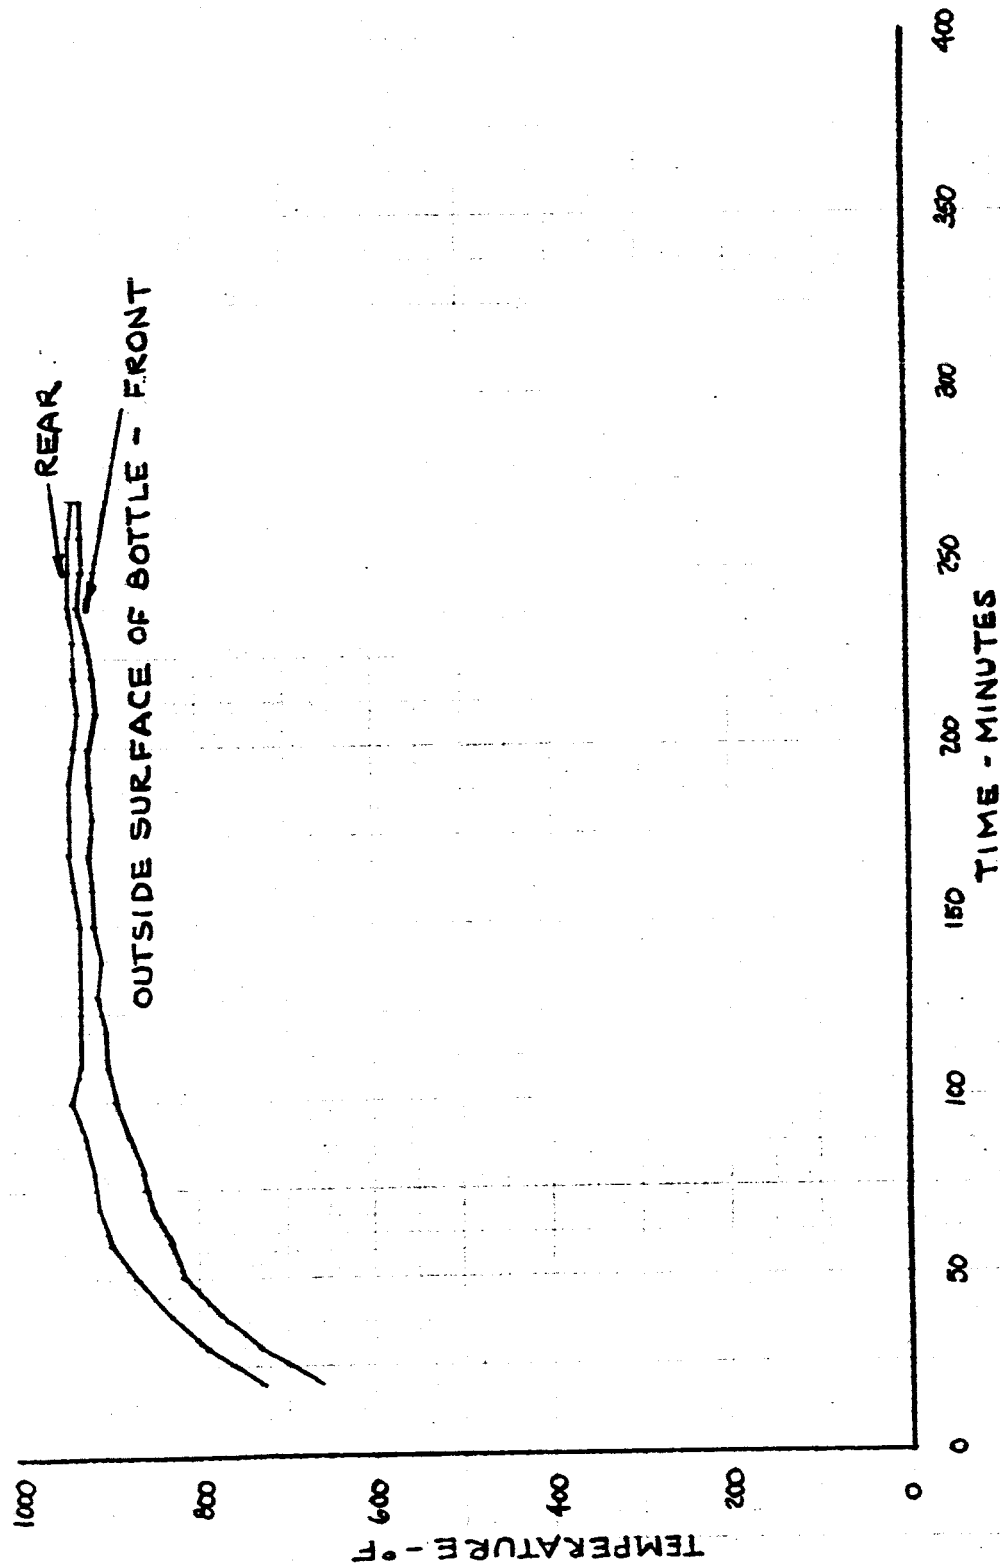
FIG. 6: TEMPERATURE-TIME HISTORY, S/N 0023, INITIAL FURN. TEMP. 900°F

As stated in the Introduction, the last five units to be heat treated were charged into a hot furnace and subsequently three units (S/N 0023, 0025, 0026) were placed in a rejected status because the test bar elongation values were below the minimum specified (see Table I). During heat treatment these units had the same three external surface thermocouples as did the previous units. It was immediately suspected that the test bars had been overheated. The temperature charts did not indicate any overheating of the bottles. Each test bar that had a low elongation value was examined metallographically and it was verified that they had been overheated. At the same time, samples were removed from either end of all three bottles and these micrographs showed no evidence of overheating. All of these photomicrographs are presented herein as Appendix A. Figures 6 to 11 show the Temperature-Time Histories and Temperature Distributions for these three units. If these figures are compared with Figs. 2 and 4, it will be seen that these units were heated at a significantly higher rate than the test unit of Fig. 2. This means that, initially, the controller set points must have been higher than the test run, probably 960-970°F. Unfortunately, no permanent records exist as to the actual settings for the processing of these units. It is concluded, however, that during the early part of the cycle (0-100 minutes), the furnace air was as high as 960-970°F and from Fig. 2, the test bars reached the same range. The bottles, however, never exceeded 945°F. The evidence that the bottles were not overheated consists of the following:

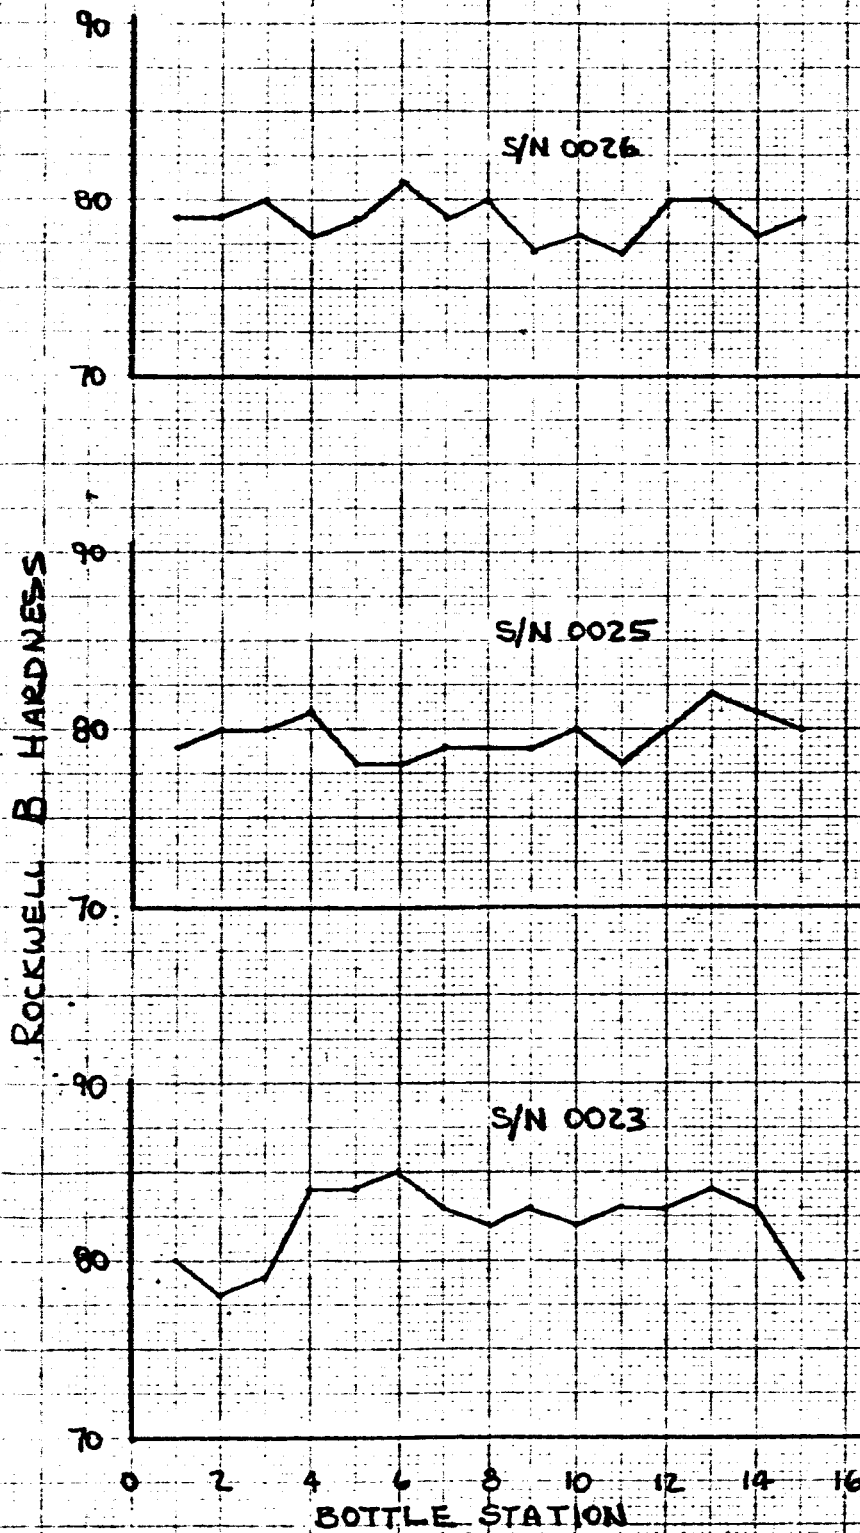
FIG. 12: HARDNESS SURVEYS

For completeness, the hardness data for these units is shown in Fig. 12.

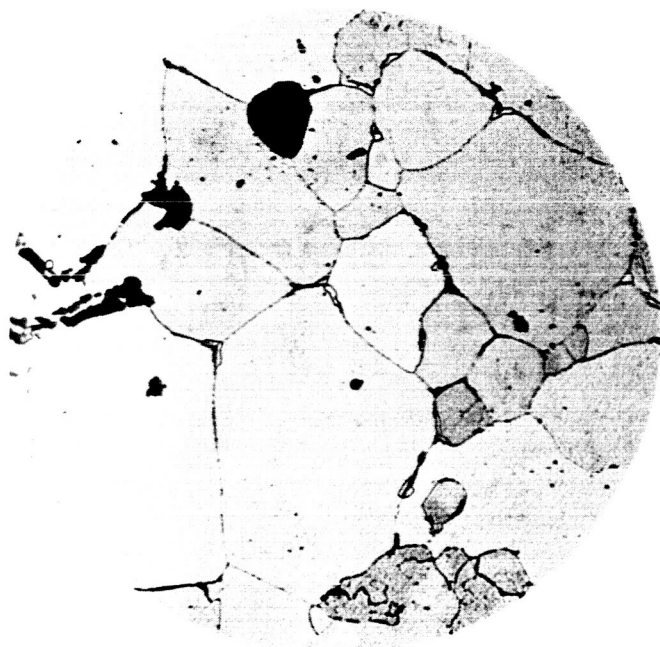
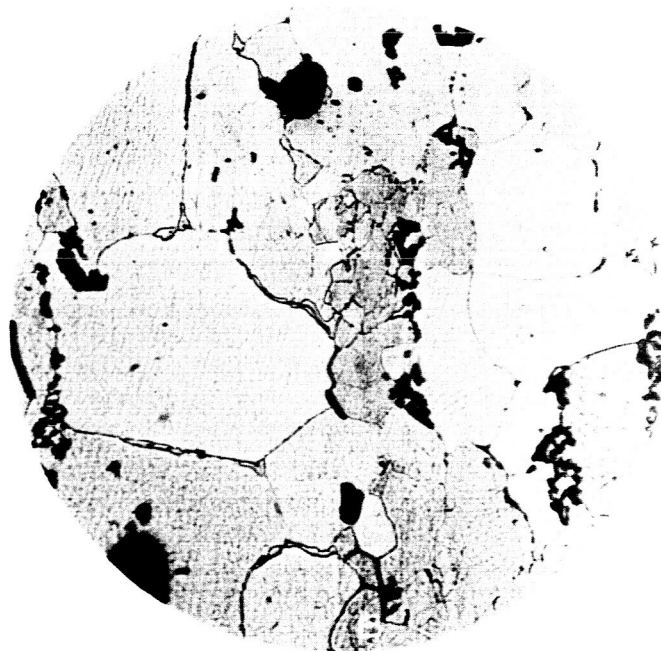
ML 11872C

Metallographic structure of tensile test bar T2, S/N 0023, front position, showing extensive solid solution grain boundary melting and high temperature oxidation. UTS 75.1 ksi, TyS 71.5 ksi, Elong. 1.5%.

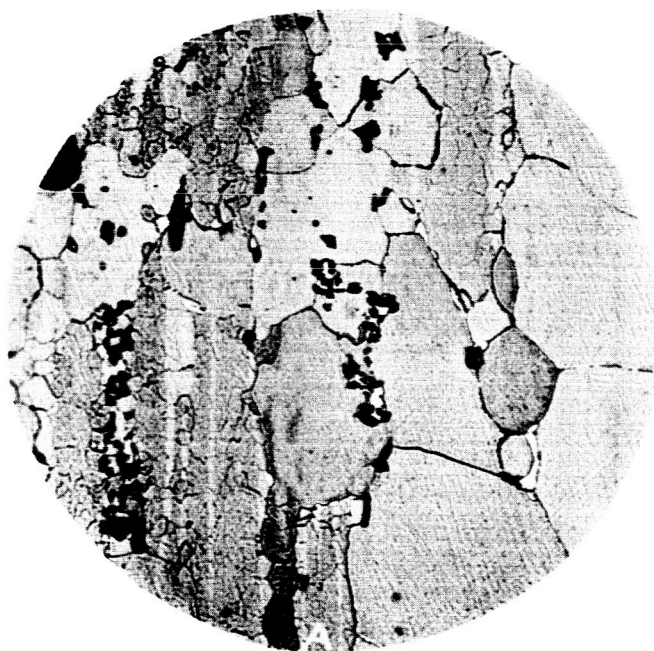
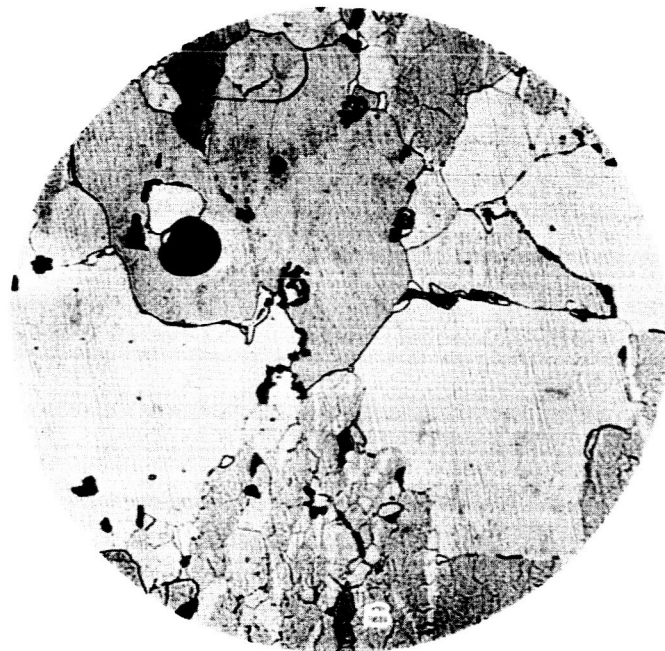
ML 118730

Metallographic structure of tensile test bar L4, S/N 0023, showing solid solution grain boundary melting, eutectic melting, and high temperature oxidation. UTS 81.3 ksi, TYS 76.0 ksi, Elong. 5.5%.

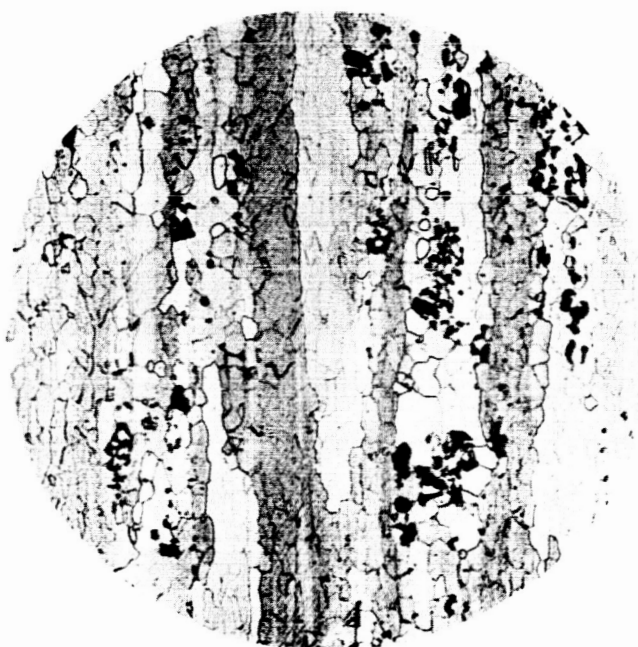
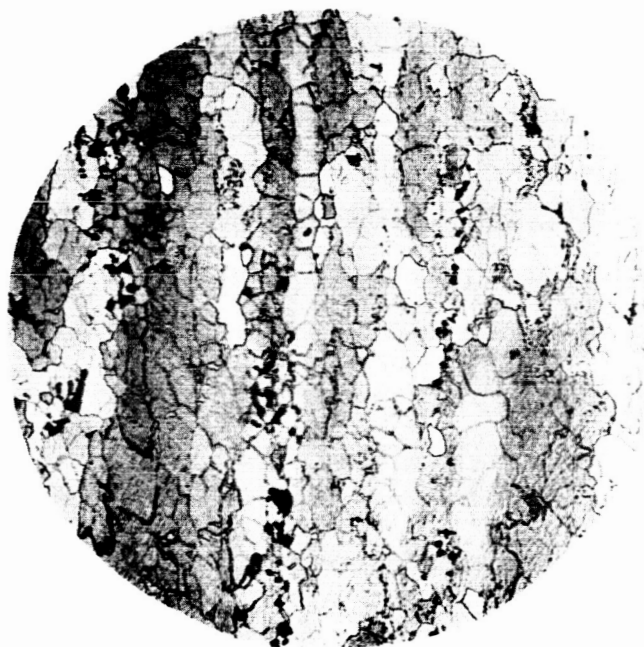
ML 11874C
Etchant:
Keller's

Metallographic structure of test section removed from front end position of bottle, S/N 0023, showing satisfactory heat treated condition for 2014-T6 alloy.

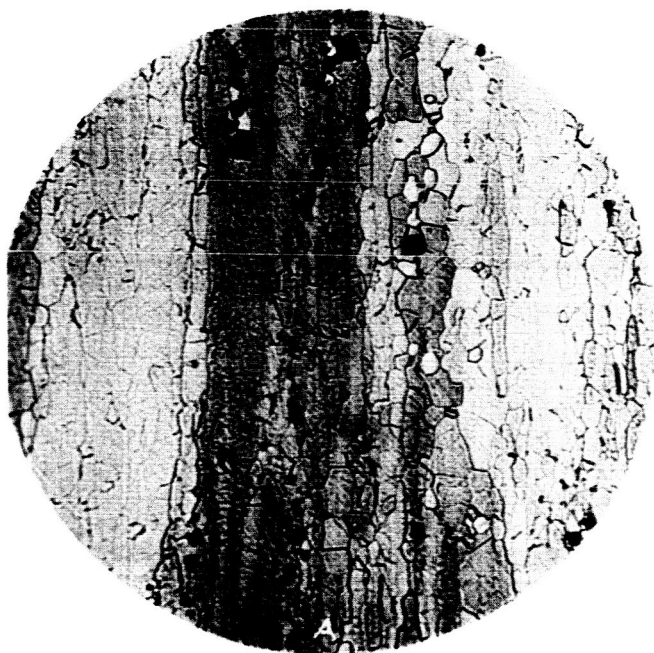
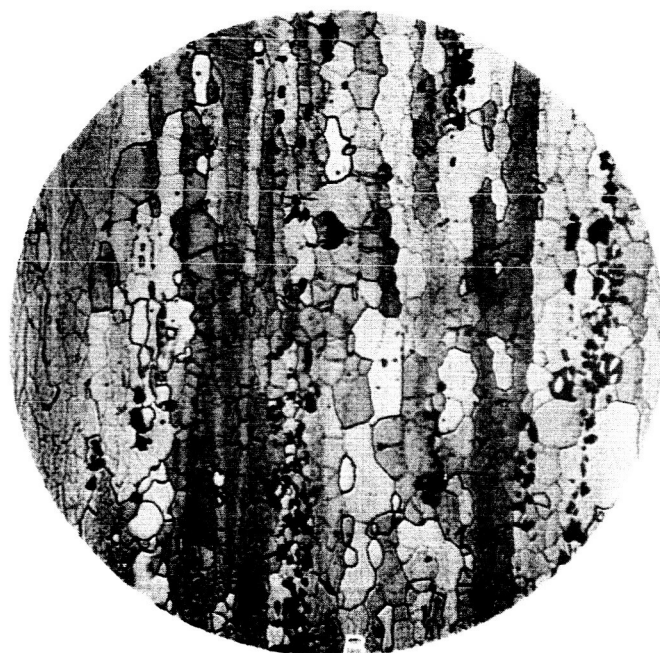
ML 118750
Etchant:
Keller's

Metallographic structure of test section removed from back end position of bottle, S/N 0023, showing satisfactory heat treated condition for 2014-T6 alloy.

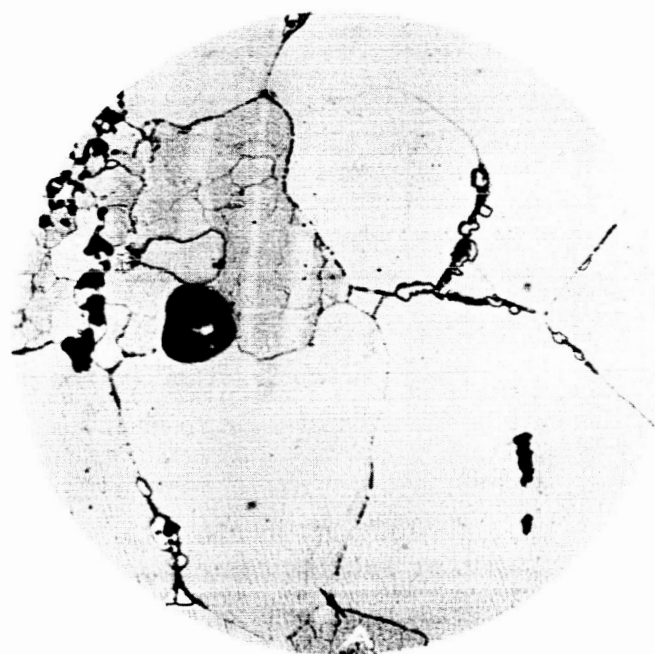
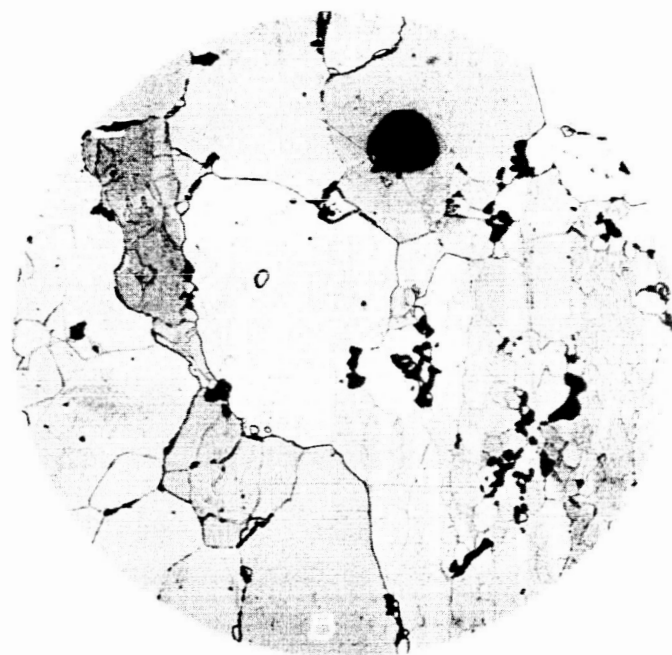
ML 118760

Metallographic structure of tensile test bar L3, S/N 0025, front end position showing extensive solid solution grain boundary melting and high temperature oxidation. UtS 77.9 ksi, TyS 73.6 ksi, Elong. 5.5%.

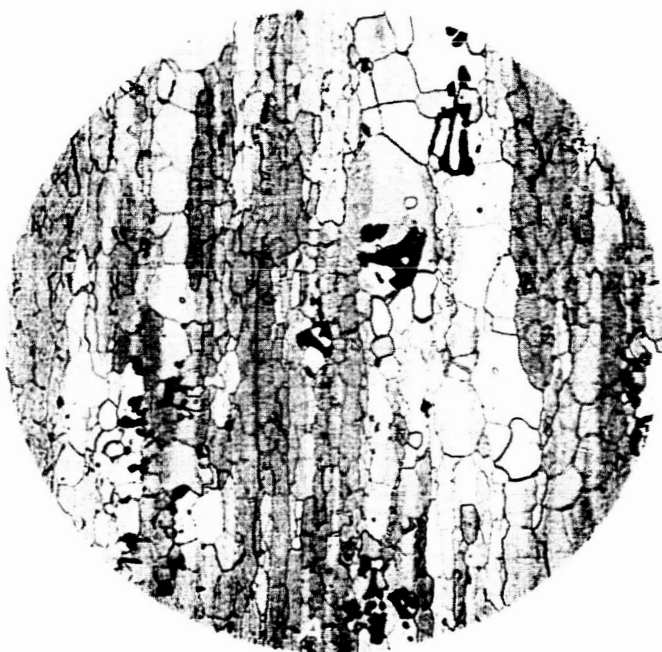
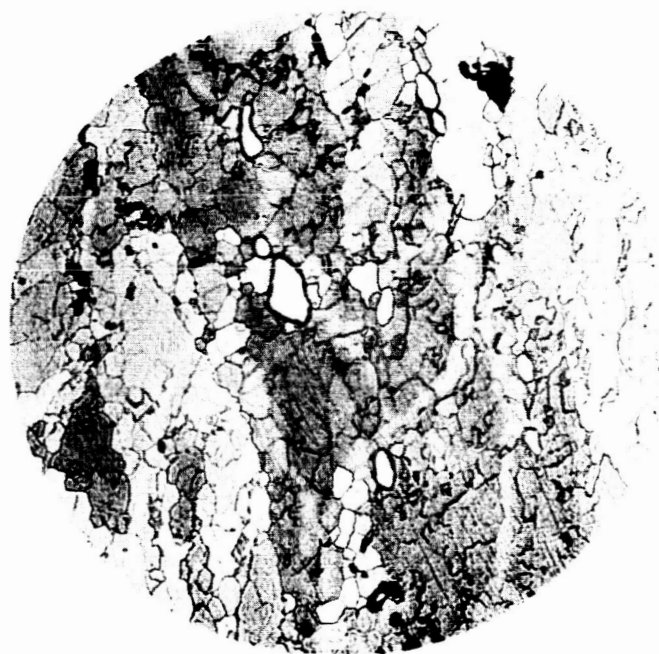
ML 11877C

Metallographic structure of test section removed from front end position of bottle, S/N 0025, showing satisfactory heat treated condition for 2014-T6 alloy.

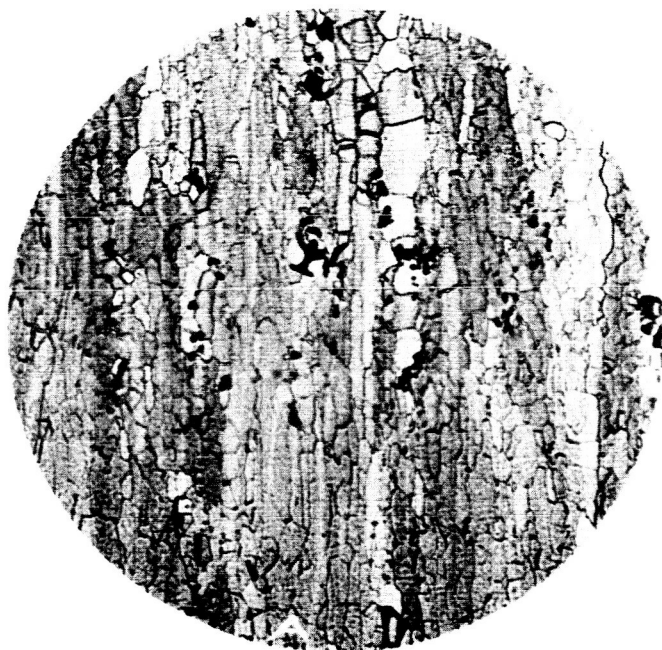
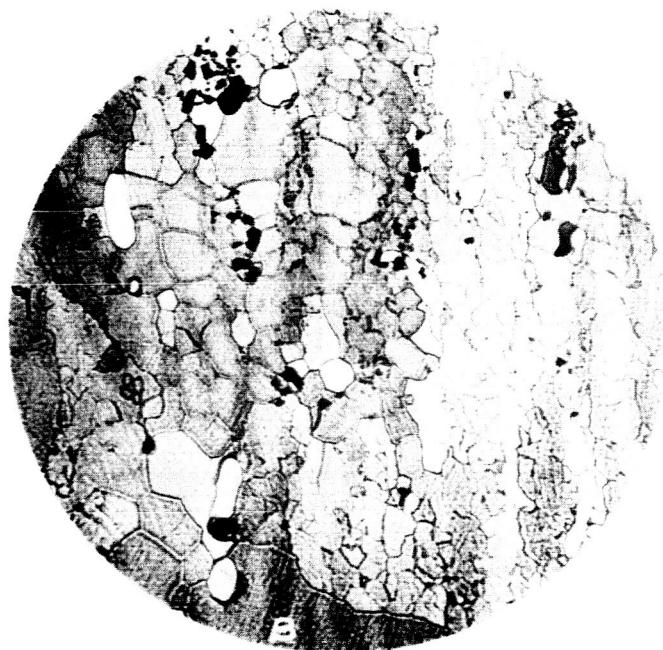
ML 11878C
Etchant:
Keller's

Metallographic structure of test section removed from back end position of bottle, S/N 0025, showing satisfactory heat treated condition for 2014-T6 alloy.

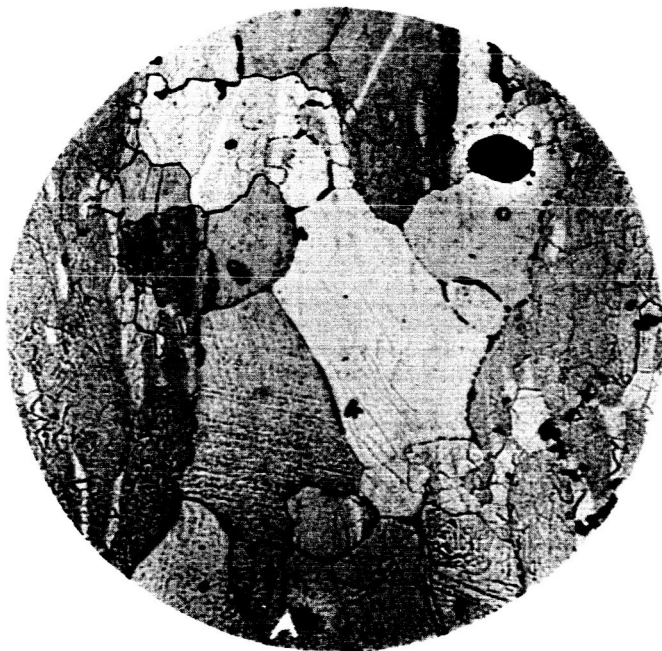
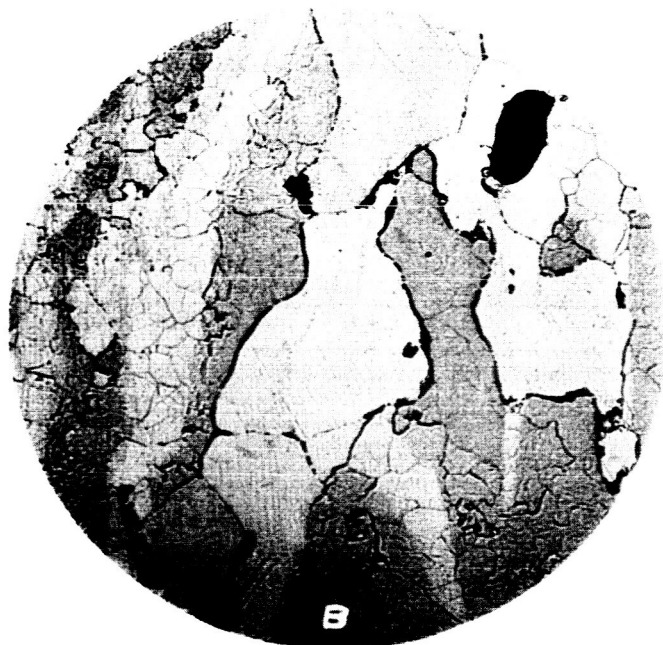
ML 11879C
Etchant:
Keller's

Metallographic structure of tensile test bar 11, S/N 0026,
showing extensive solid solution grain boundary melting and
high temperature oxidation. UTS 76.3 ksi, TS 69.4 ksi,
Elong. 5.5%.

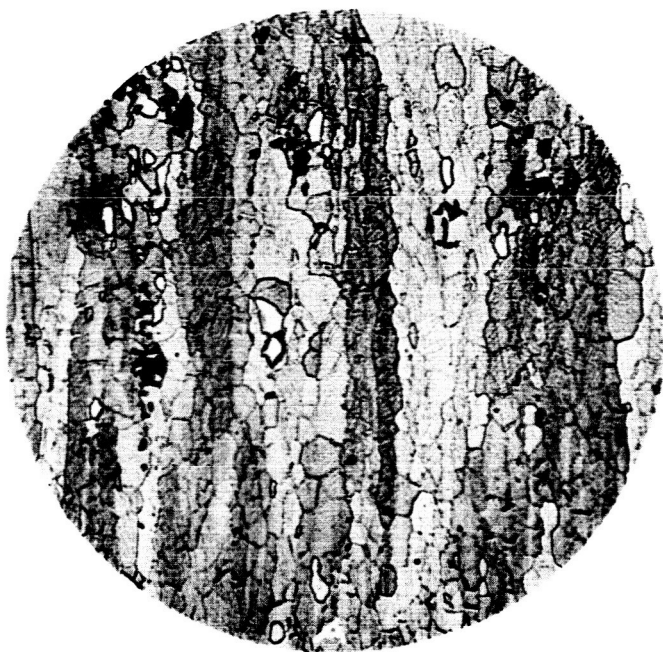
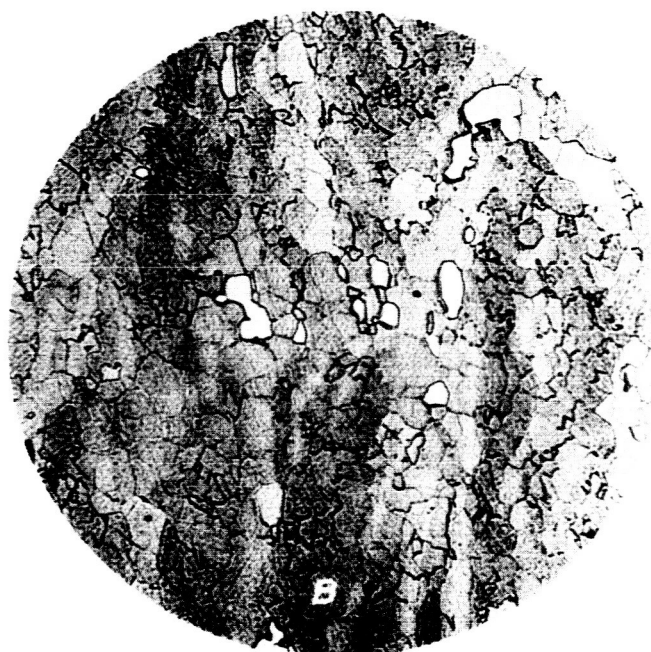
ML 11880C
Etchant:
Keller's

Metallographic structure of test section removed from front end position of bottle, C/N 0026, showing satisfactory heat treated condition for 2014-T6 alloy.

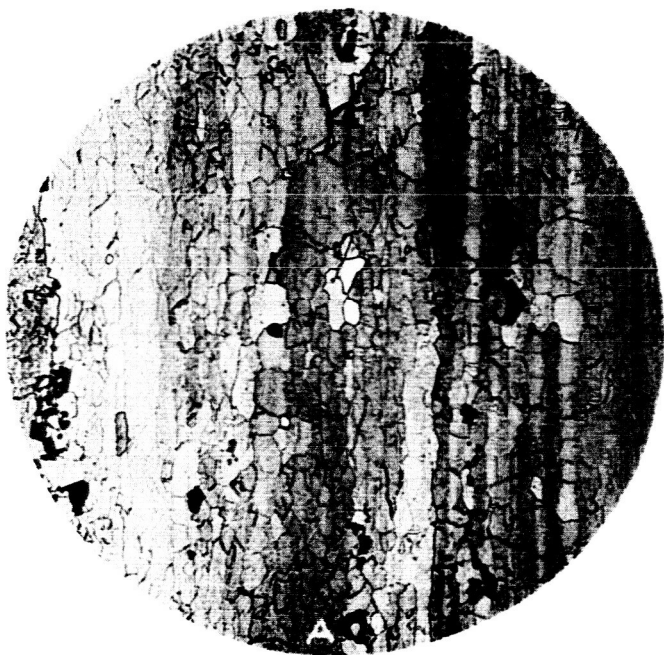
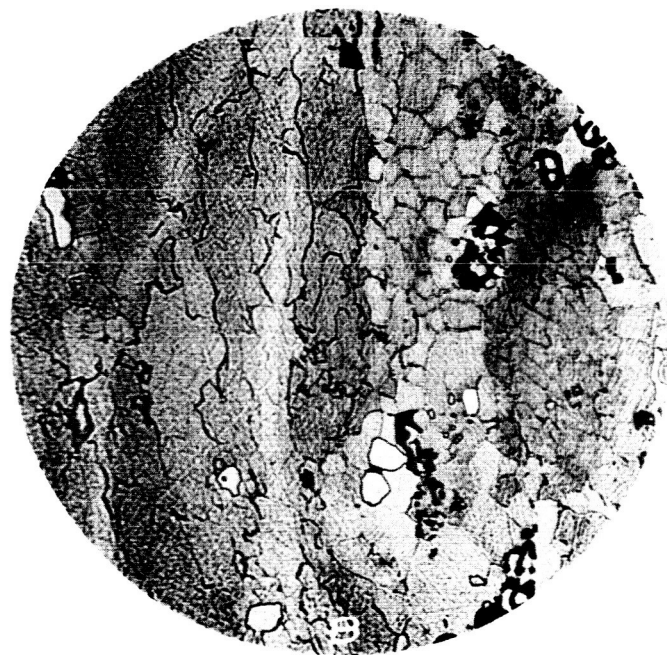
ML 11881C
Etchant:
Keller's

Metallographic structure of test section removed from back end position of bottle, S/N 0026, showing satisfactory heat treated condition for 2014-T6 alloy.

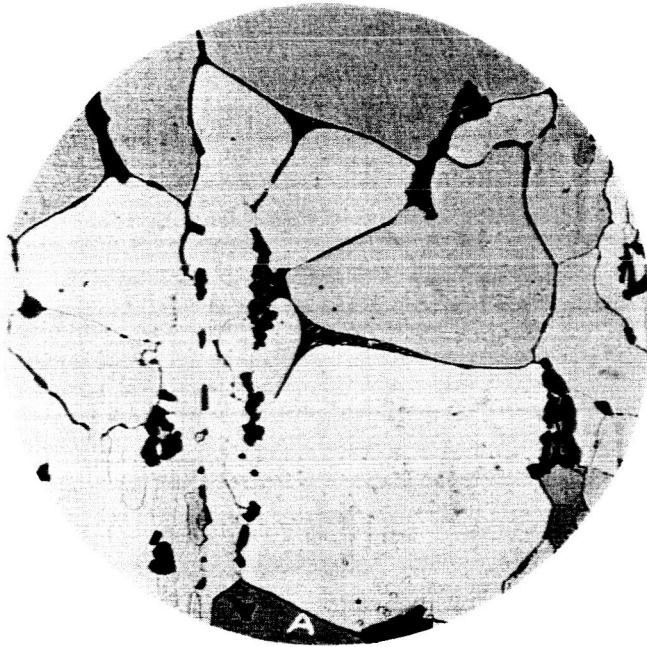
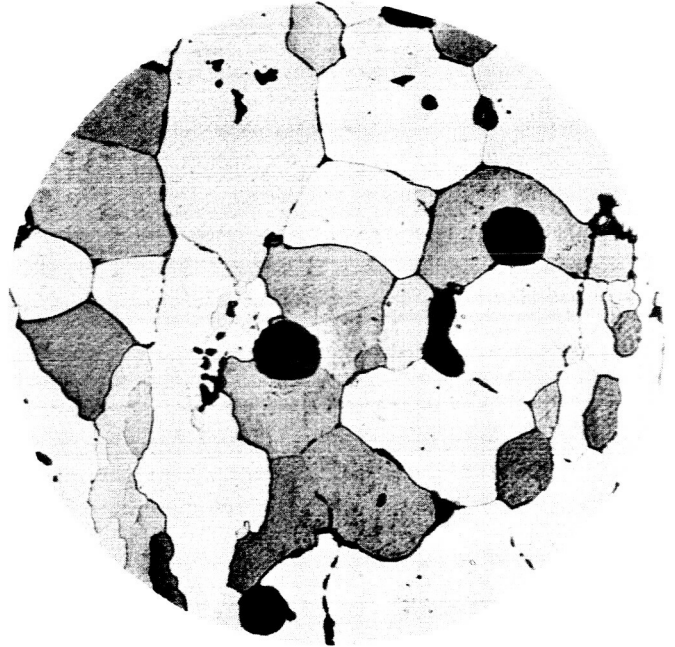
ML 11816C
Etchant:
Keller's

These data show that the elongation and conductivity experience a sharp decrease for a solution treating temperature above 955°F. A rather startling change in microstructure also is apparent between 955°F and 960°F.

Photomicrograph of 2014-T6 Aluminum Alloy Extrusion, S/N 0035, showing high temperature oxidation, eutectic and solid solution grain boundary melting within metallographic structure after solution heat treatment at 960°F/30 minutes soak, cold water quench, and aged at 320°F for 20 hours.

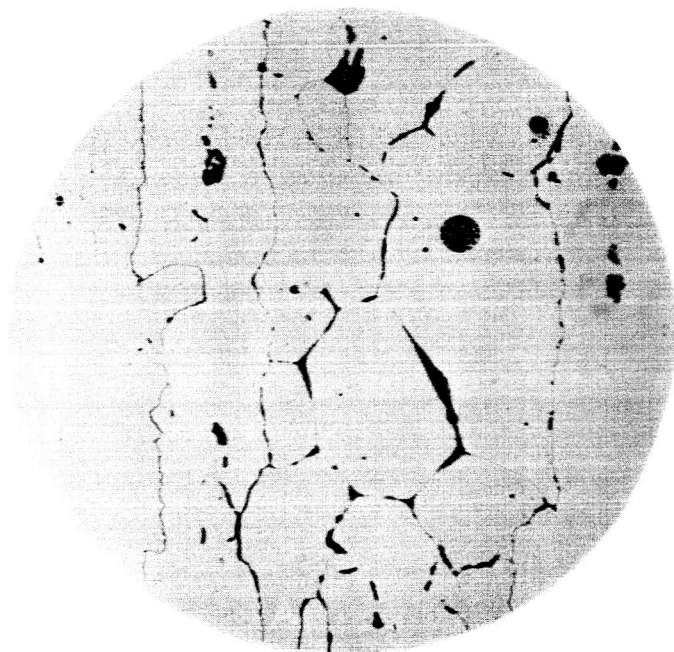
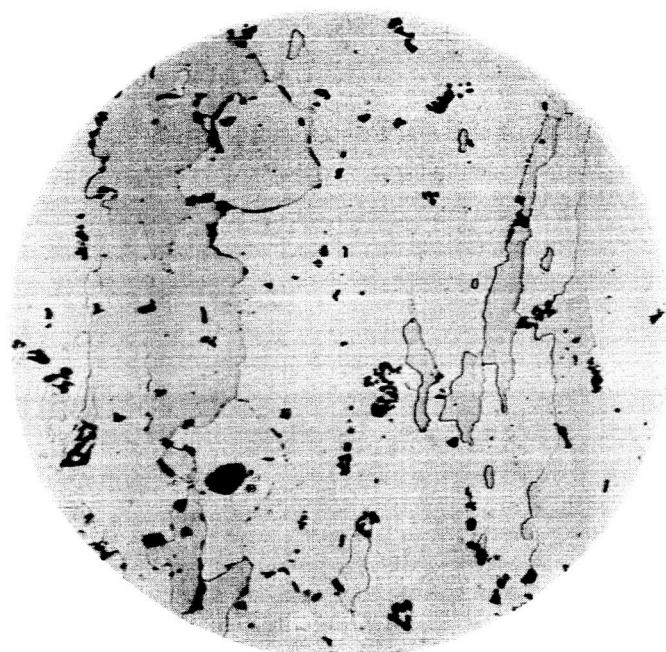
ML 11818C
Etchant:
Keller's

Photomicrograph of 2014-T6 Aluminum Alloy Extrusion, S/N 0035, showing high temperature oxidation, eutectic and solid solution grain boundary melting within metallographic structure after solution heat treatment at 965°F/30 minutes soak, cold water quench, and aged at 320°F for 20 hours.

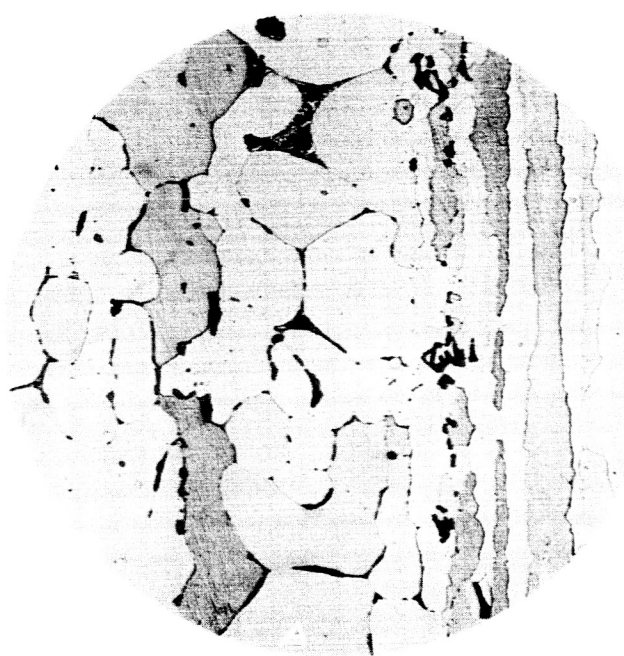
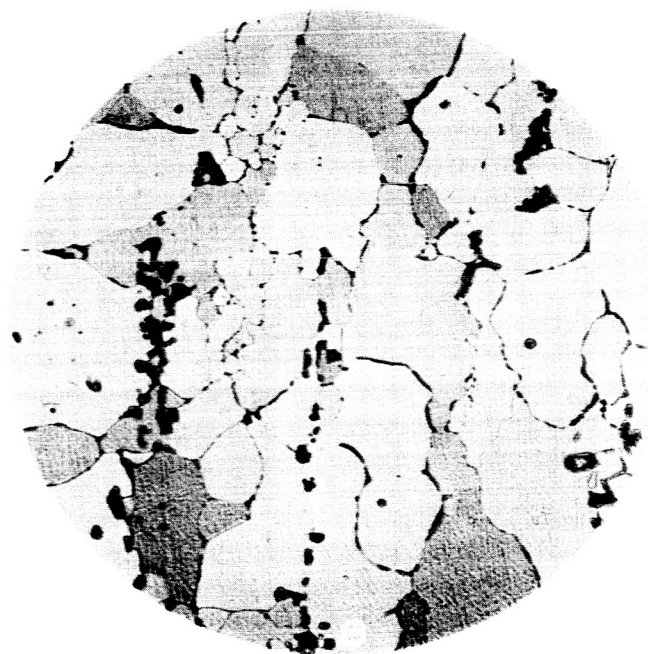
ML 11820C

Photomicrograph of 2014-T6 Aluminum Alloy Extrusion, S/N 0035, showing high temperature oxidation, eutectic and solid solution grain boundary melting within metallographic structure after solution heat treatment at 970°F/30 minutes soak, cold water quench, and aged at 320°F for 20 hours.
